BOISE CITY INVENTORY OF HISTORIC PLACES
Boise City Historic Preservation Commission, City Hall,
150 North Capitol Boulevard, Boise, Idaho 83702

Survey: North 9th Street Reconnaissance Survey

Inventory No. 169
 Date Completed: June 1992
 Photo(s): R3-#9
 State #: 01-17791
 Survey #: 178

Street Address: 818 Eastman

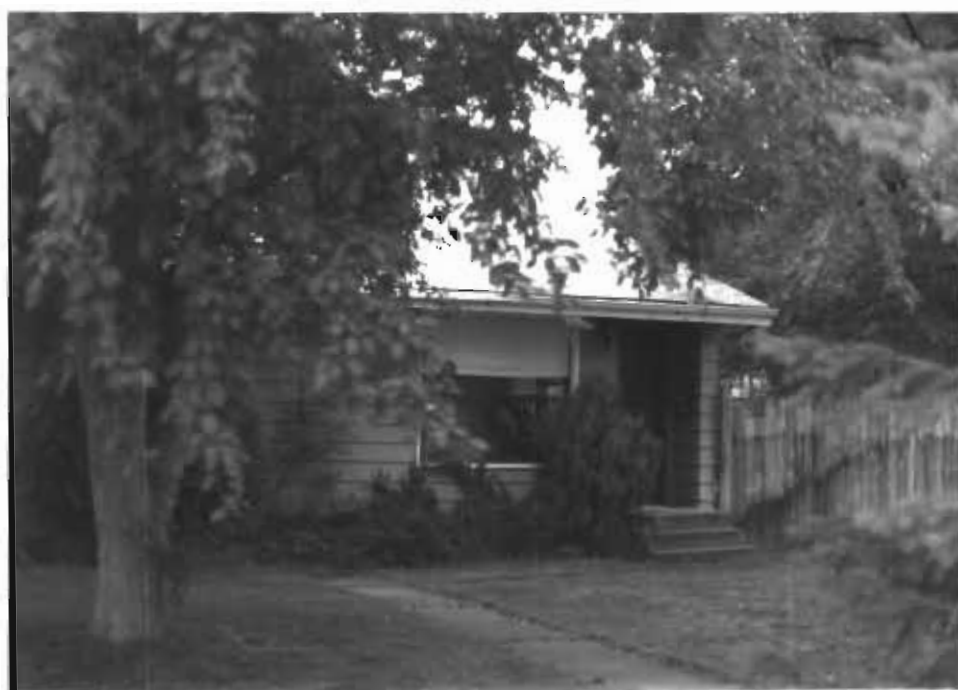
818

Comment: Poor-fair integrity (Eastman addition); storm windows; looks like it has had some changes (front facing Eastman could have been the addition, roof breaks there; includes garage structure
