BOISE CITY INVENTORY OF HISTORIC PLACES

Inventory No. 084

Historic: T.A. Blake House

Street Address: 1915 Harrison

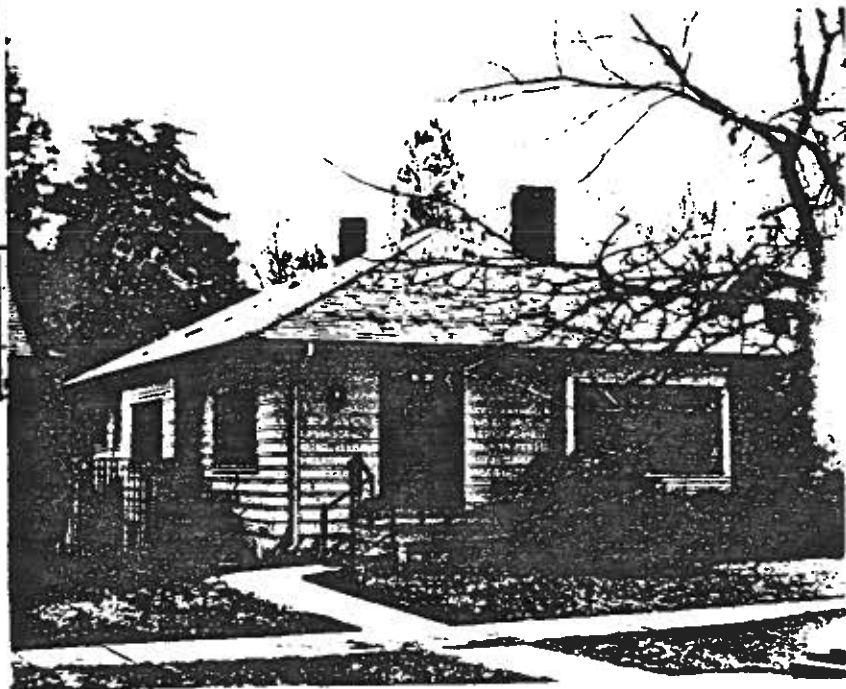
Photo(s): R6-16

Comment: Well kept.

The J. A. Blake residence, was built in 1923. This hipped roof cottage has an unusual window bay in front, which appears to be an alteration. There is a recessed left side entry, with paneled door and an entablature. Both sides have bay windows, and the shingles are in alternating wide and narrow horizontal bands.

12/86 Re-roofed.
