Rock Fall Study
Warm Springs Village
Warm Springs Avenue
Boise, Idaho

August 26, 2016

RE: **Rock Fall Study**
Warm Springs Village
Warm Springs Avenue
Boise, Idaho

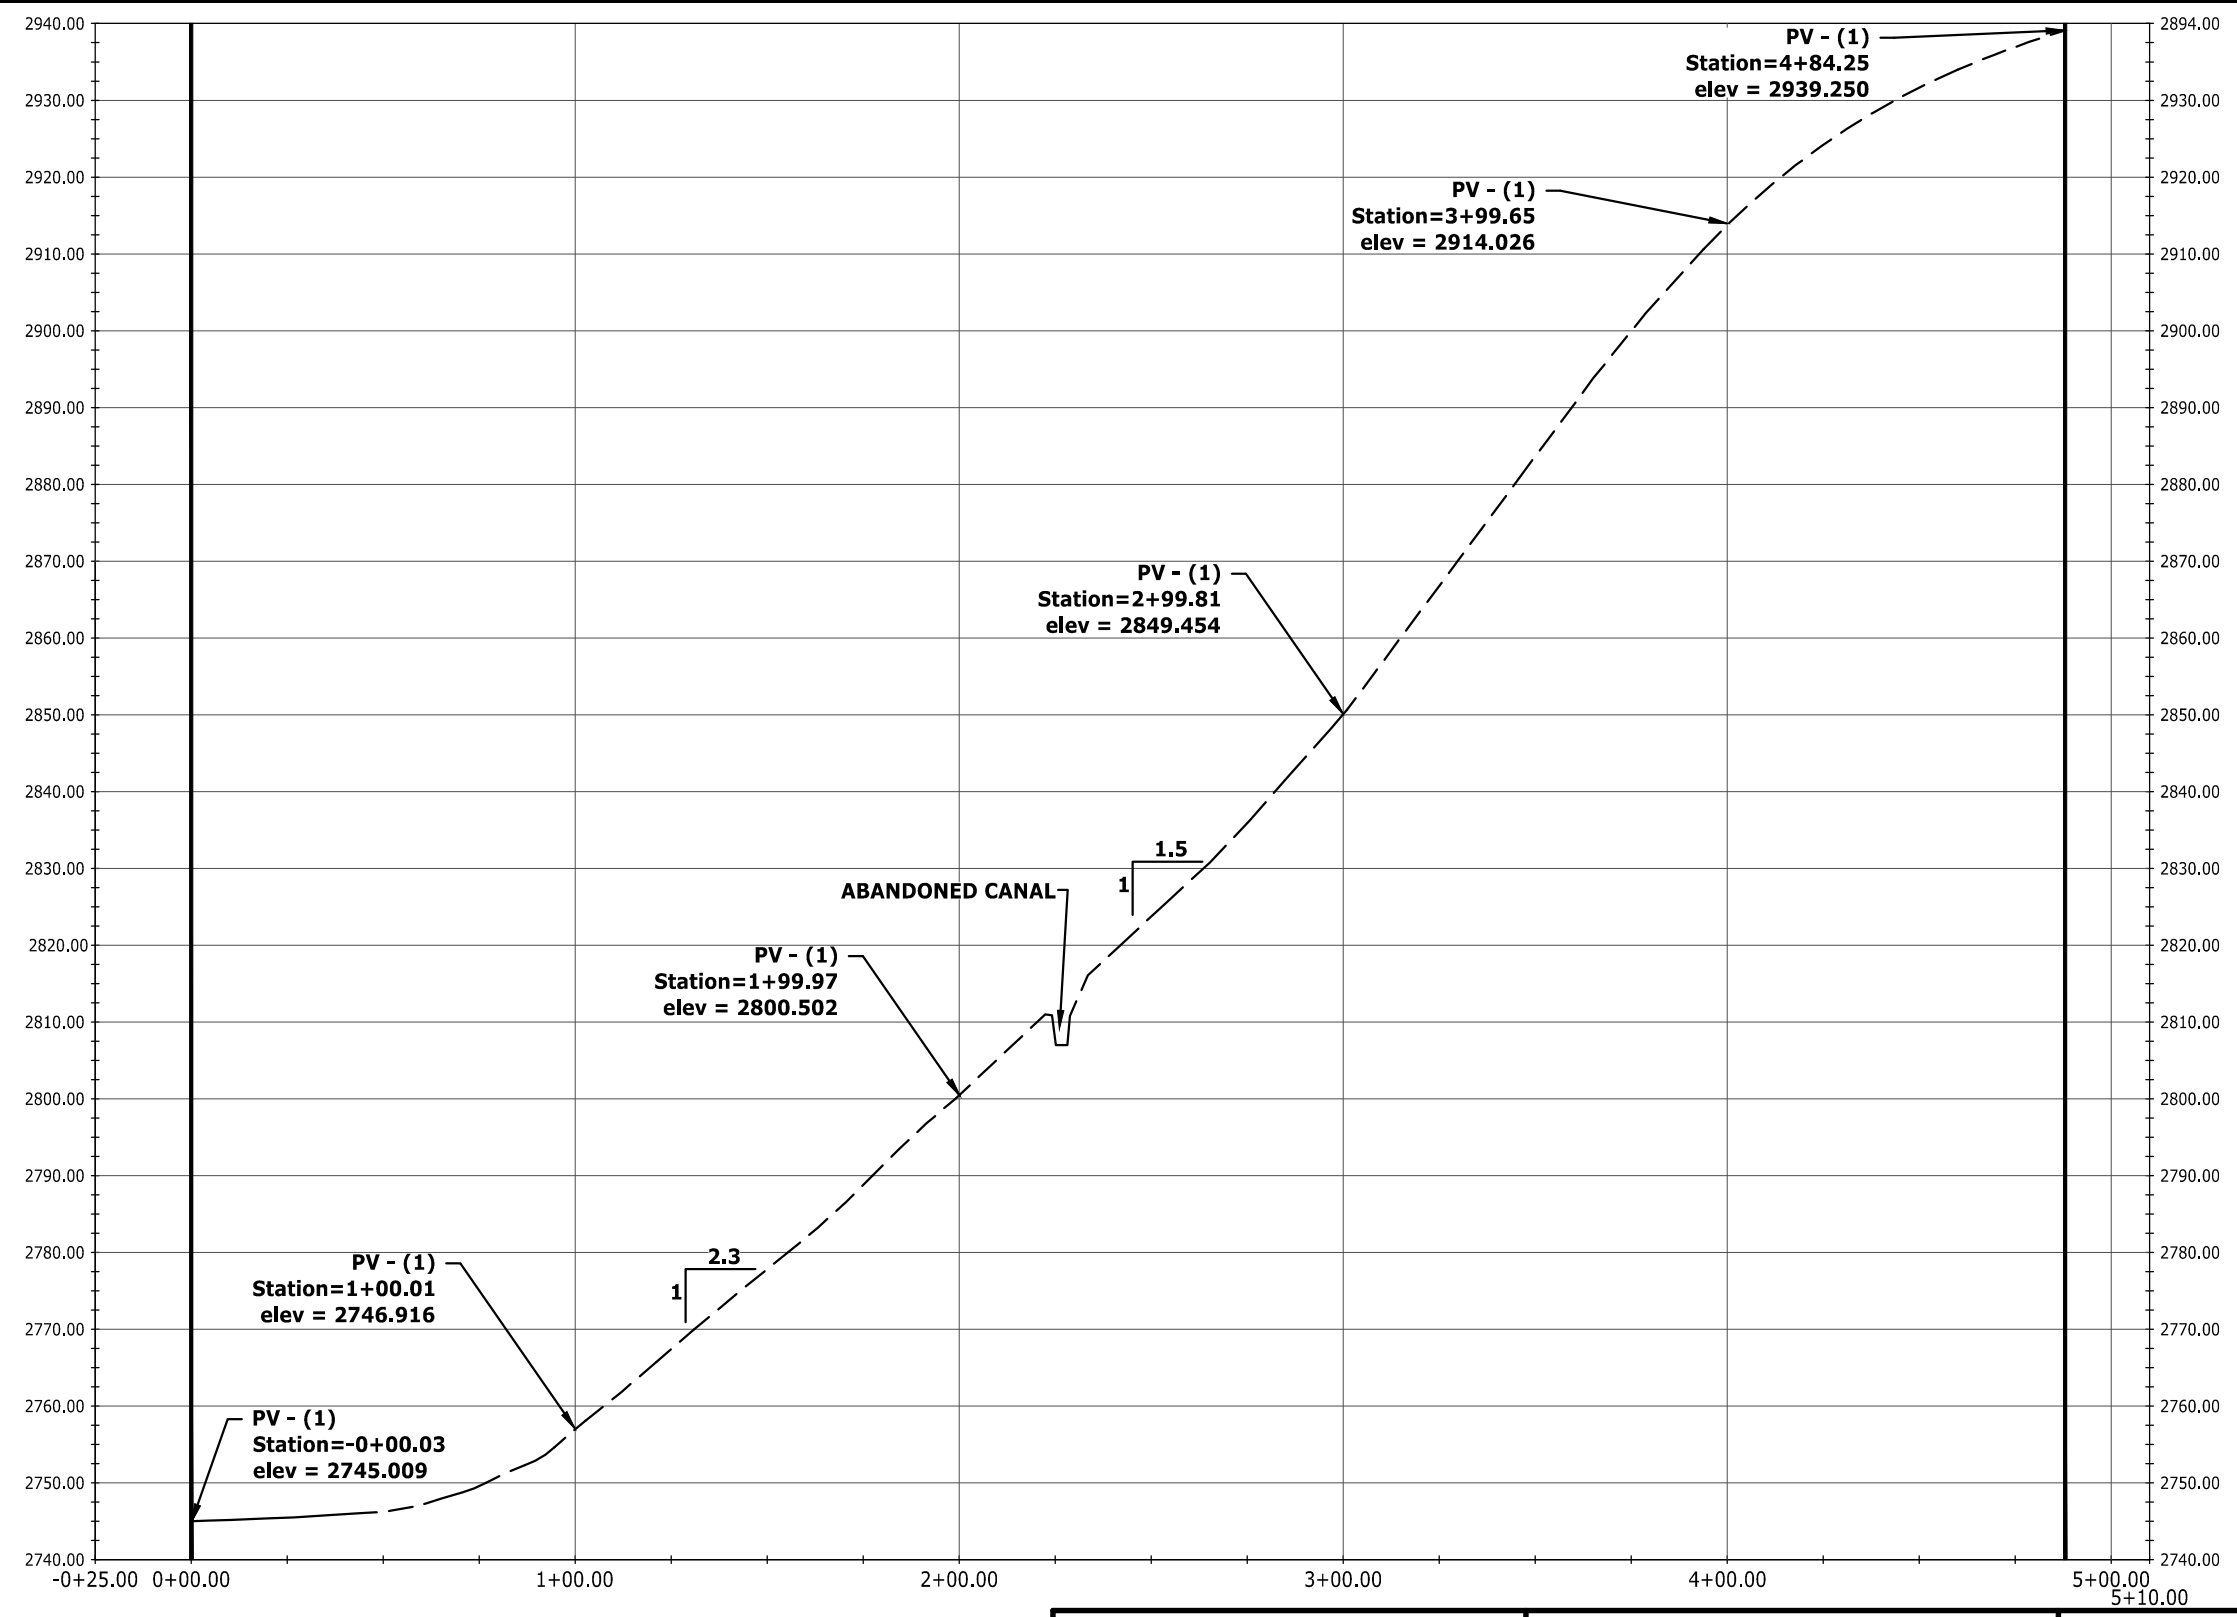
DRAWING DATE: 8-26-2016		CRITICAL SECTION B-B' ROCK FALL STUDY Warm Springs Village Warm Springs Avenue Boise, Idaho

We downloaded the City of Boise GIS 2-foot contour aerial topography to evaluate the slope aperture throughout the rock fall study area. We observed 2 critically steep slope areas. The first is located in the south, and extends from proposed Lot 49 easterly and up slope through the tram trail shown as *Critical Steep Slope Alignment*, Section B-B' on Plate 1. The topography for this cross section is shown on Plate 2, Critical Section B-B'. Photograph 2 in Appendix A shows the lower portion of this slope.

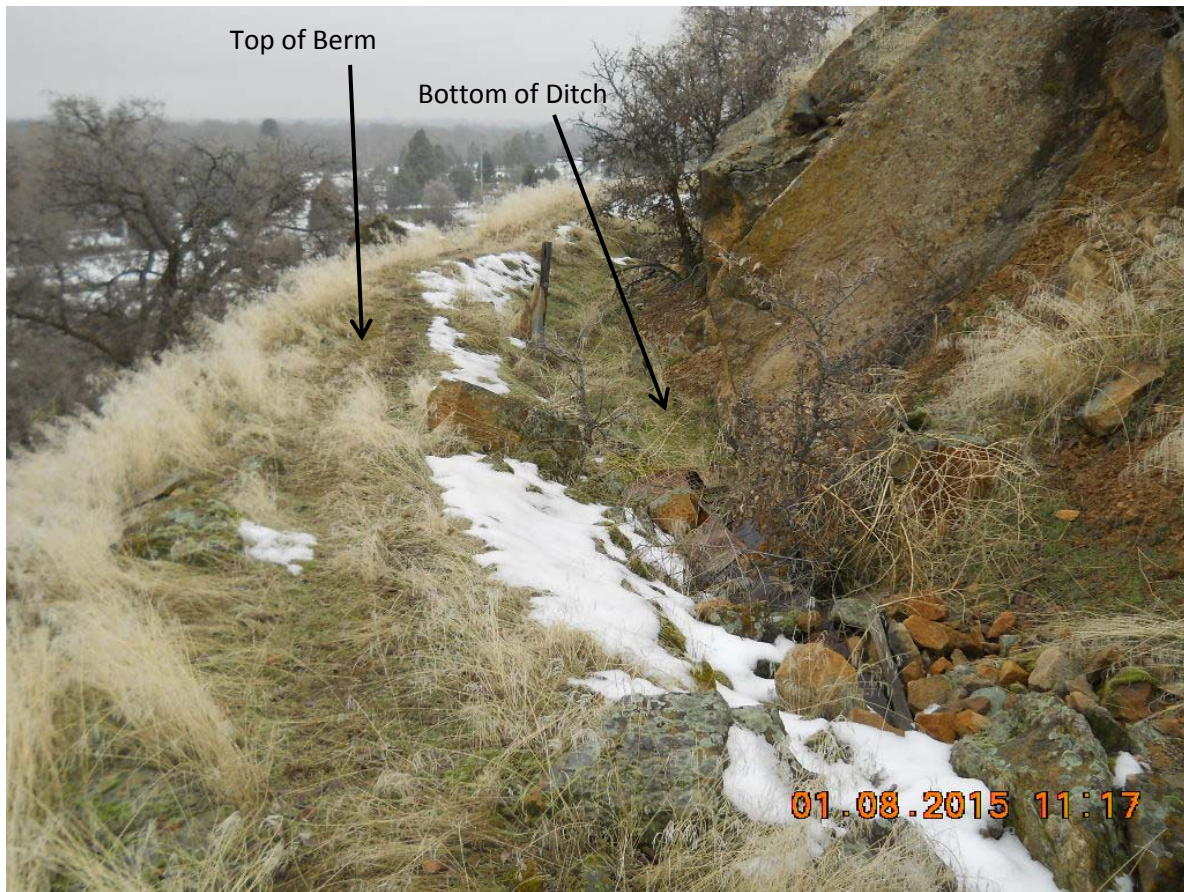
Photograph 1 – Former Abandoned Penitentiary Canal (Note Catchment of Rock Fall)

The former Penitentiary Canal, which is currently abandoned, traverses across the study area approximately halfway up the slope. The canal is approximately 3 to 5 feet in depth and has an earth berm on the downhill side of the canal. We observed small boulders collected within the canal as shown on Photograph 1 in Appendix A. The ground surface in the study area contains numerous sandstone boulders, which vary considerably in size. Some boulders are as large as 25 feet in length with thicknesses of 3 to 5 feet. The boulders are generally blocky and rectangular in shape. The ground surface consists predominantly of clayey and silty sand soil. Vegetation cover consists of native grasses, shrubs, and occasional trees.

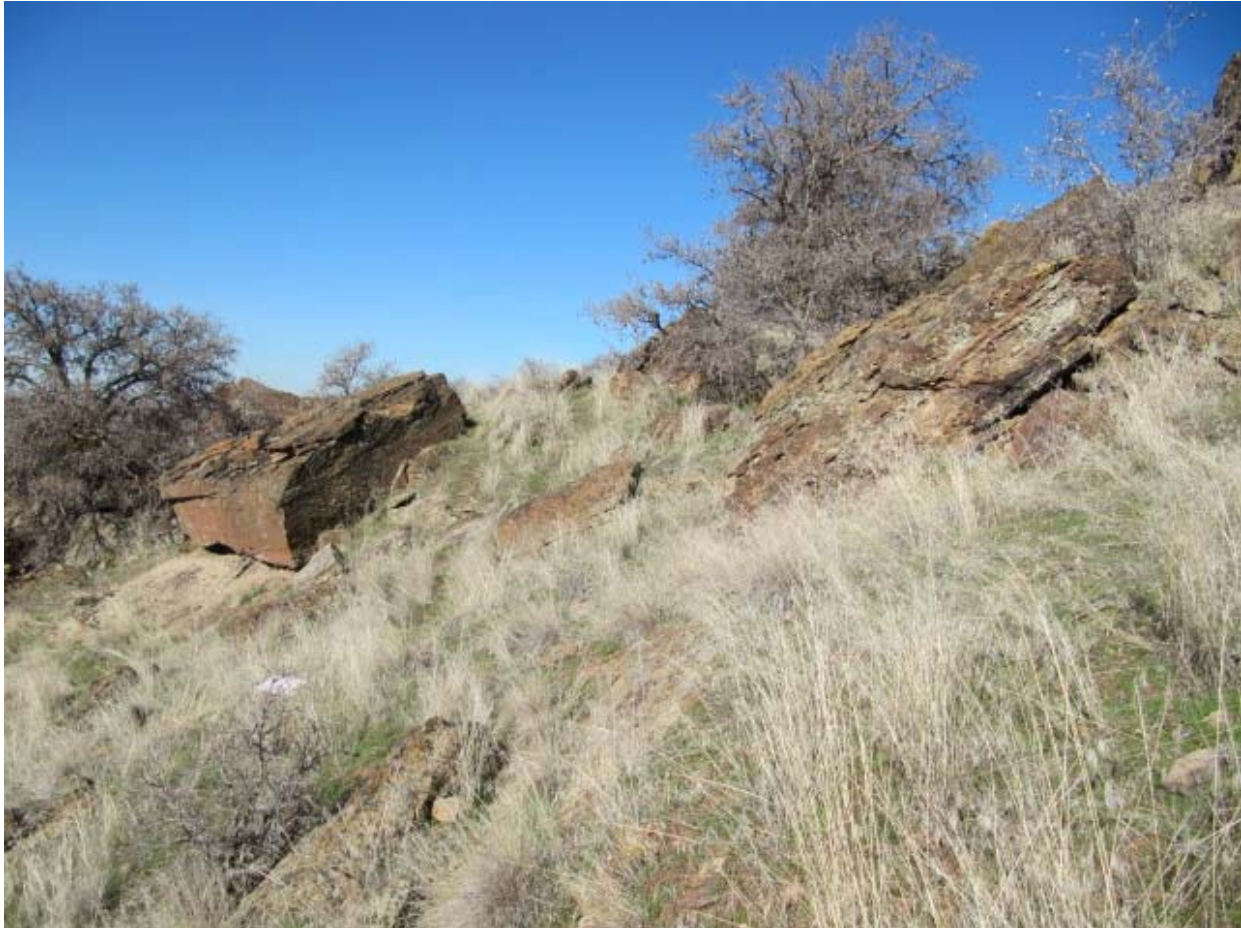
Photograph 5 – Boulders Along Critical Slope Alignment

In February 2015 STRATA made a number of site visits to observe and measure boulders in the critical steep slope topographic areas, as identified in the above section. We documented boulders based on their size, shape, orientation, and soil embedment. Generally, the boulders were blocky and rectangular in shape. The size of the most critical boulders, along the steep alignments, varied up to a size of 13 foot long by 8 foot wide by 4 ½ foot in depth. The boulder orientation were evaluated with respect to their downslope position. Boulders that had orientations that are parallel or steeper than the slope are considered unfavorable and prone to toppling. We also observed whether the boulders appeared to be embedded significantly into soil slopes. Photographs 5 and 6 in Appendix A show boulders with potentially unfavorable orientations, located along the critical steep slope alignment Section B-B' in the southern portion of the study area.
